Manhole Inspection Summary

Manhole # S15EE_012MH

Insp Date: **5/13/09 12:28 PM**

Location Address: **1500 BRADDISH AVE**

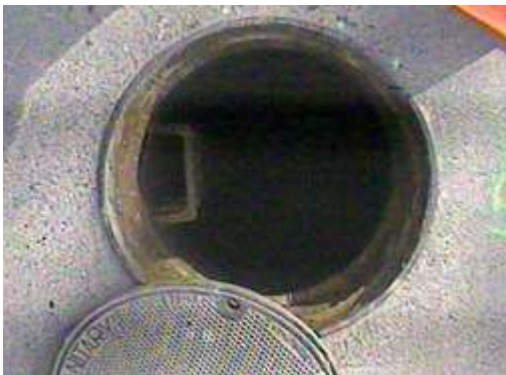
Top View

frame offset

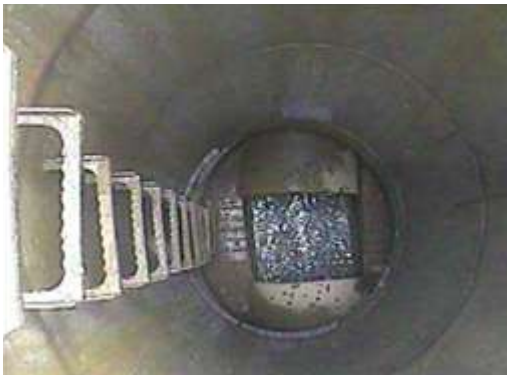
Top View

Offset: **1** (in.)

Condition: ☒ Sound ☐ Cracked ☐ Leaks

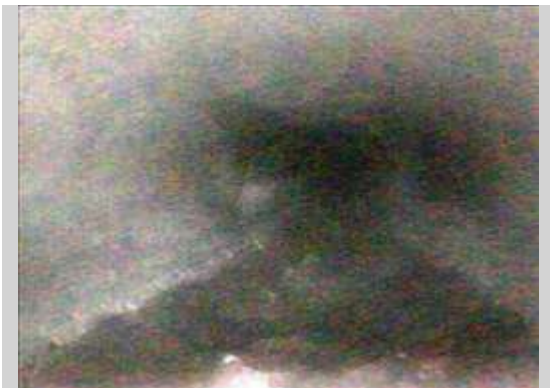
6 O'Clock Inflow

33 in. Circular Gravity Sewer
Pipe In @ 6 O'Clock

frame offset

Pipe Height: **27.6** (in.) Rod and Bar
Pipe Material: **Clay** ☐ Pipe Lined
Invert Depth: **16.18** (ft.) Flow Characteristics: **Fast**
Deposits: ☒ None ☐ Mud ☐ Sludge ☐ Debris ☐ Grease
Silt Depth: (in.) Deposits Extent:
Infiltration: **None** Pipe Seal Cond: **Sound**
